Manhole Inspection Summary

Manhole # S17SS_024MH

Insp Date: **11/11/08 4:28 PM**

Location Address: **2334 OCALA AVE** Cross Street: **TOWANDA AVE**

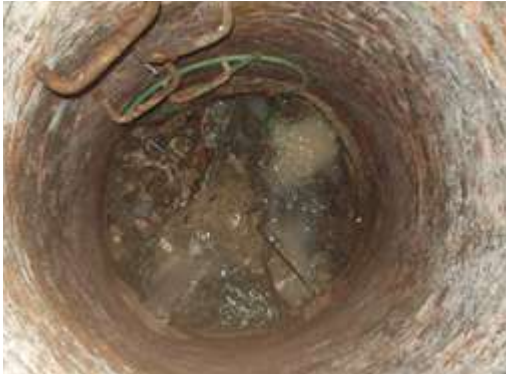
Defect 2

Surcharge ☒ **Evidence Of Surcharge** Depth: **2** (ft.) ☐ Active Surcharge Present

EVIDENCE OF ASUR

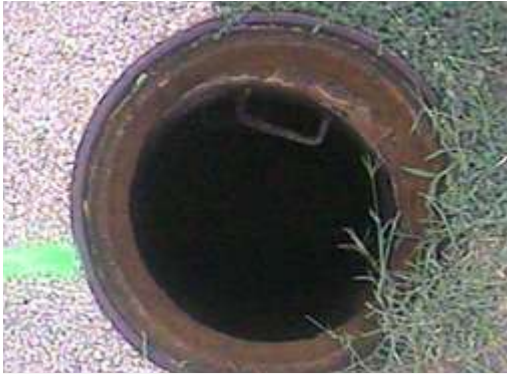
Defect 1

Frame Offset: **1** (in.) Condition: ☒ Sound ☐ Cracked ☐ Leaks

FRAME OFFSET

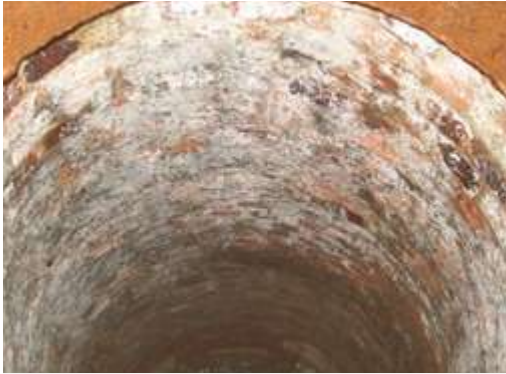
Defect 4

Condition: ☐ Sound ☒ **Cracked** ☐ Root Intrusion ☐ Loose Brick ☐ Deteriorated

CRACKED CORBEL

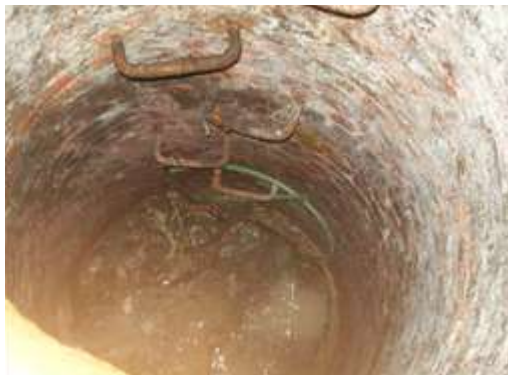
Defect 3

Steps Count: **6** Missing: **0** ☒ **Corroded**

CORRODED STEPS

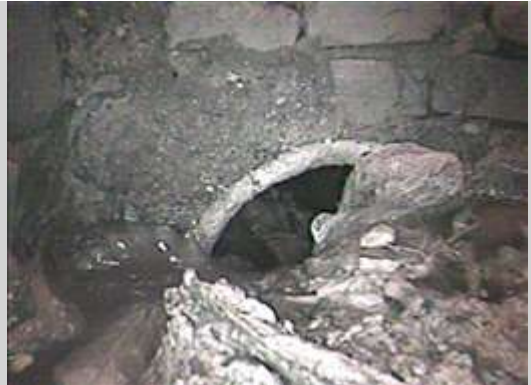
12 O'Clock Outflow

Pipe Height: (in.) Direct
Pipe Material: **Clay** ☐ Pipe Lined
Invert Depth: **11.54** (ft.) Flow Characteristics: **Slow**
Deposits: ☐ None ☐ Mud ☒ **Sludge** ☒ **Debris** ☐ Grease
Silt Depth: **6** (in.) Deposits Extent: **Heavy**
Infiltration: **None** Pipe Seal Cond: **Sound**

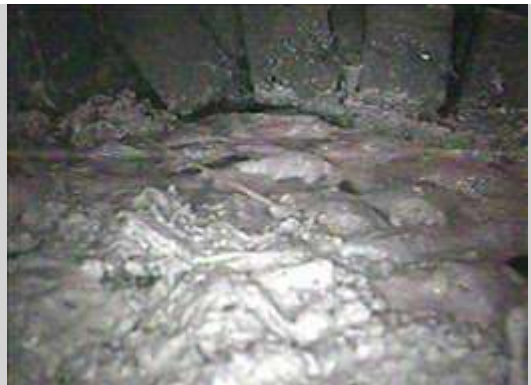
2 O'Clock Inflow

Pipe Height: (in.) Direct
Pipe Material: **Clay** ☐ Pipe Lined
Invert Depth: **10.90** (ft.) Flow Characteristics: **Slow**
Deposits: ☐ None ☐ Mud ☒ **Sludge** ☒ **Debris** ☐ Grease
Silt Depth: **8** (in.) Deposits Extent: **Heavy**
Infiltration: **None** Pipe Seal Cond: **Unknown**

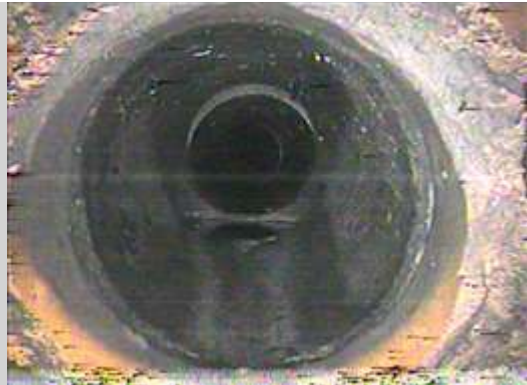
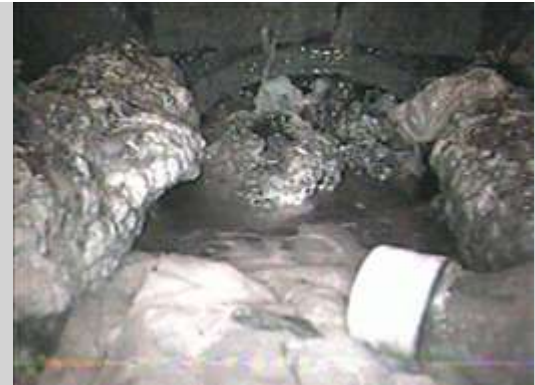
5 O'Clock Inflow

Deposits: ☐ None ☐ Mud ☐ Sludge ☒ Debris ☒ Grease

Silt Depth: **8** (in.) Deposits Extent: **Heavy**

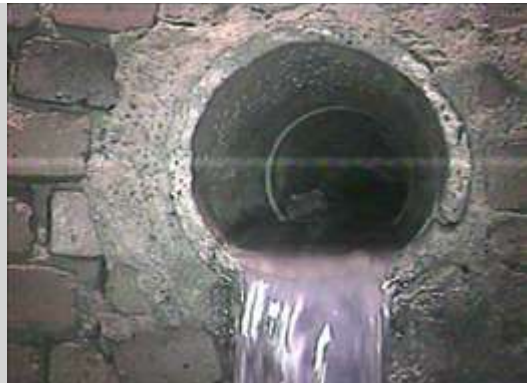
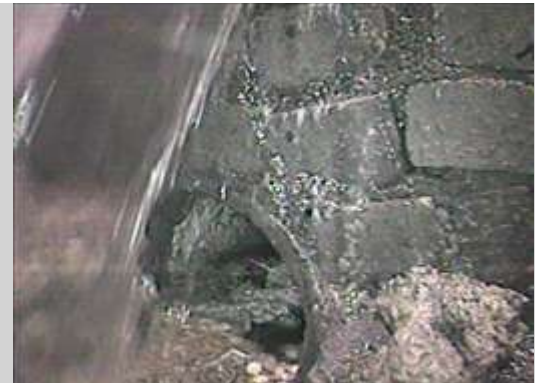
7 O'Clock Inflow

Silt Depth: **6** (in.) Deposits Extent: **Heavy**
